Infrared for Detection of Exterior Wall Moisture and Delamination: A Case Study and Comparison to FEA Predictions

*Jack M. Kleinfeld
Kleinfeld Technical Services, Inc.*

An 80-year-old building, stucco over terra cotta, was surveyed for moisture from the exterior. Solar loading was used to detect suspect areas. The results and basis of the IR are discussed. Physical probing is still in progress, but some results are available. A comparison of the results to heat transfer simulation of the system using FEA is also presented.

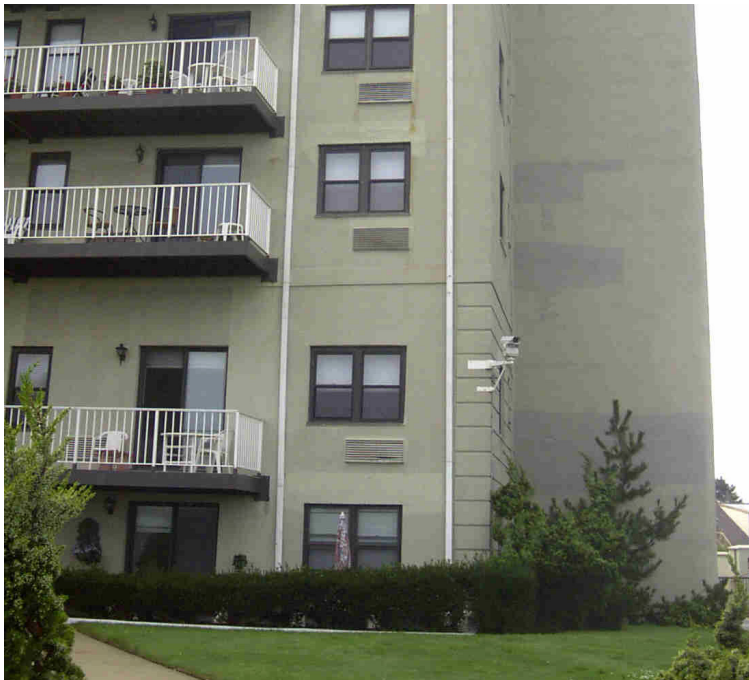
Figure 1A. Photo of wall section

Figure 1 shows a typical finding, presented in different palettes and temperature spans for clarity and accompanied by a photo of the area. The image at the bottom with a wider temperature range shows three measurement areas indicating the temperatures for the apparently normal, wet, and delaminated areas. The temperatures are approximate, as explained above. The delaminated area is saturated hot.

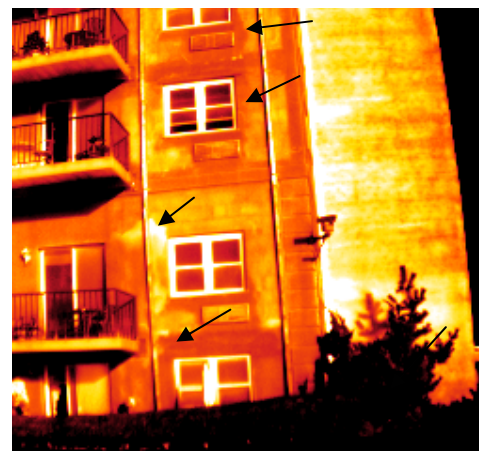
Figure 2B. SE elevation already receiving sun and warming. Problem areas have become visible, as shown by the arrows. 7:50:28 a.m.

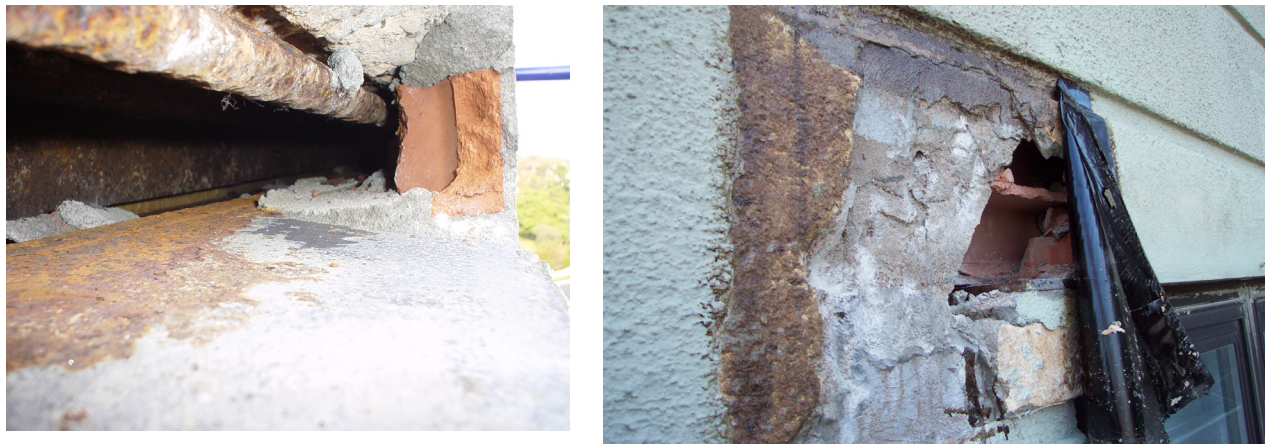
Figure 4. Photos after opening the wall. Note the rusted condition of the steel.

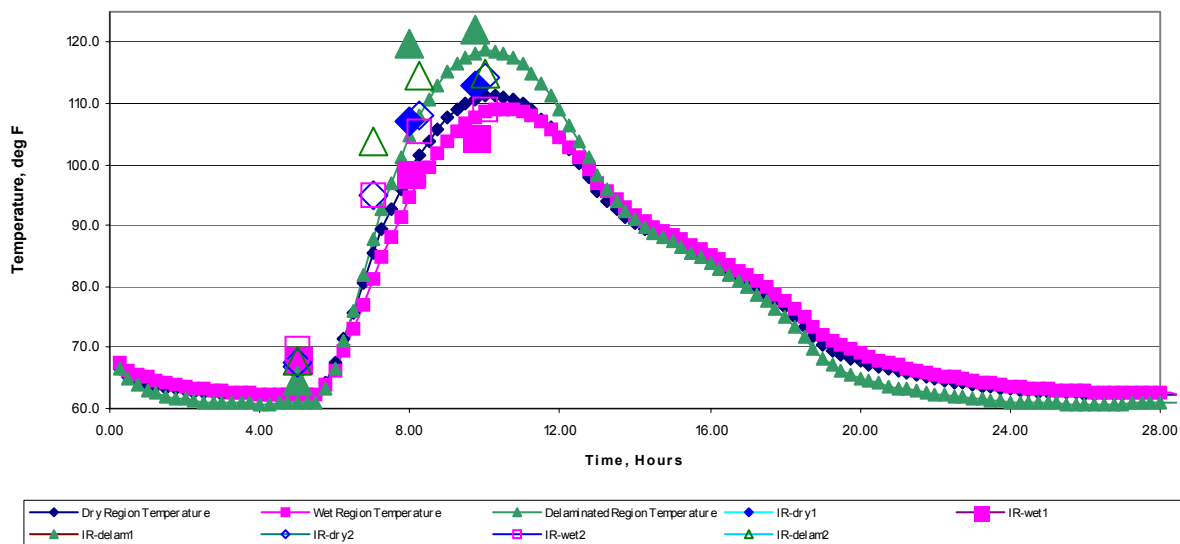
Figure 7 shows the predicted thermal history of the three sections along with data taken from the IR images. The behavior of the three sections is similar to each other, but note the following differences. The peak temperatures, occurring around 10:30 a.m. EST, are in the order expected: the delaminated area is hottest, and the wet area is coolest. Furthermore, the nighttime temperatures are in reversed order, with the delaminated area coolest and the wet area warmest. The swing or range of temperature is least for the wet area and greatest for the delaminated area. This is consistent with our understanding of how the wall interacts with its surroundings. The available data for the section of wall shown above in the IR images is plotted on the same graph as oversized data markers, along with data from a second section of the building with the same SE orientation. There is good agreement, especially considering the number of assumptions that were made, in the values of the temperatures, the trend of the temperatures, and the relative order of the temperatures.

Figure 7. Predicted exterior surface temperature vs. time for various wall sections

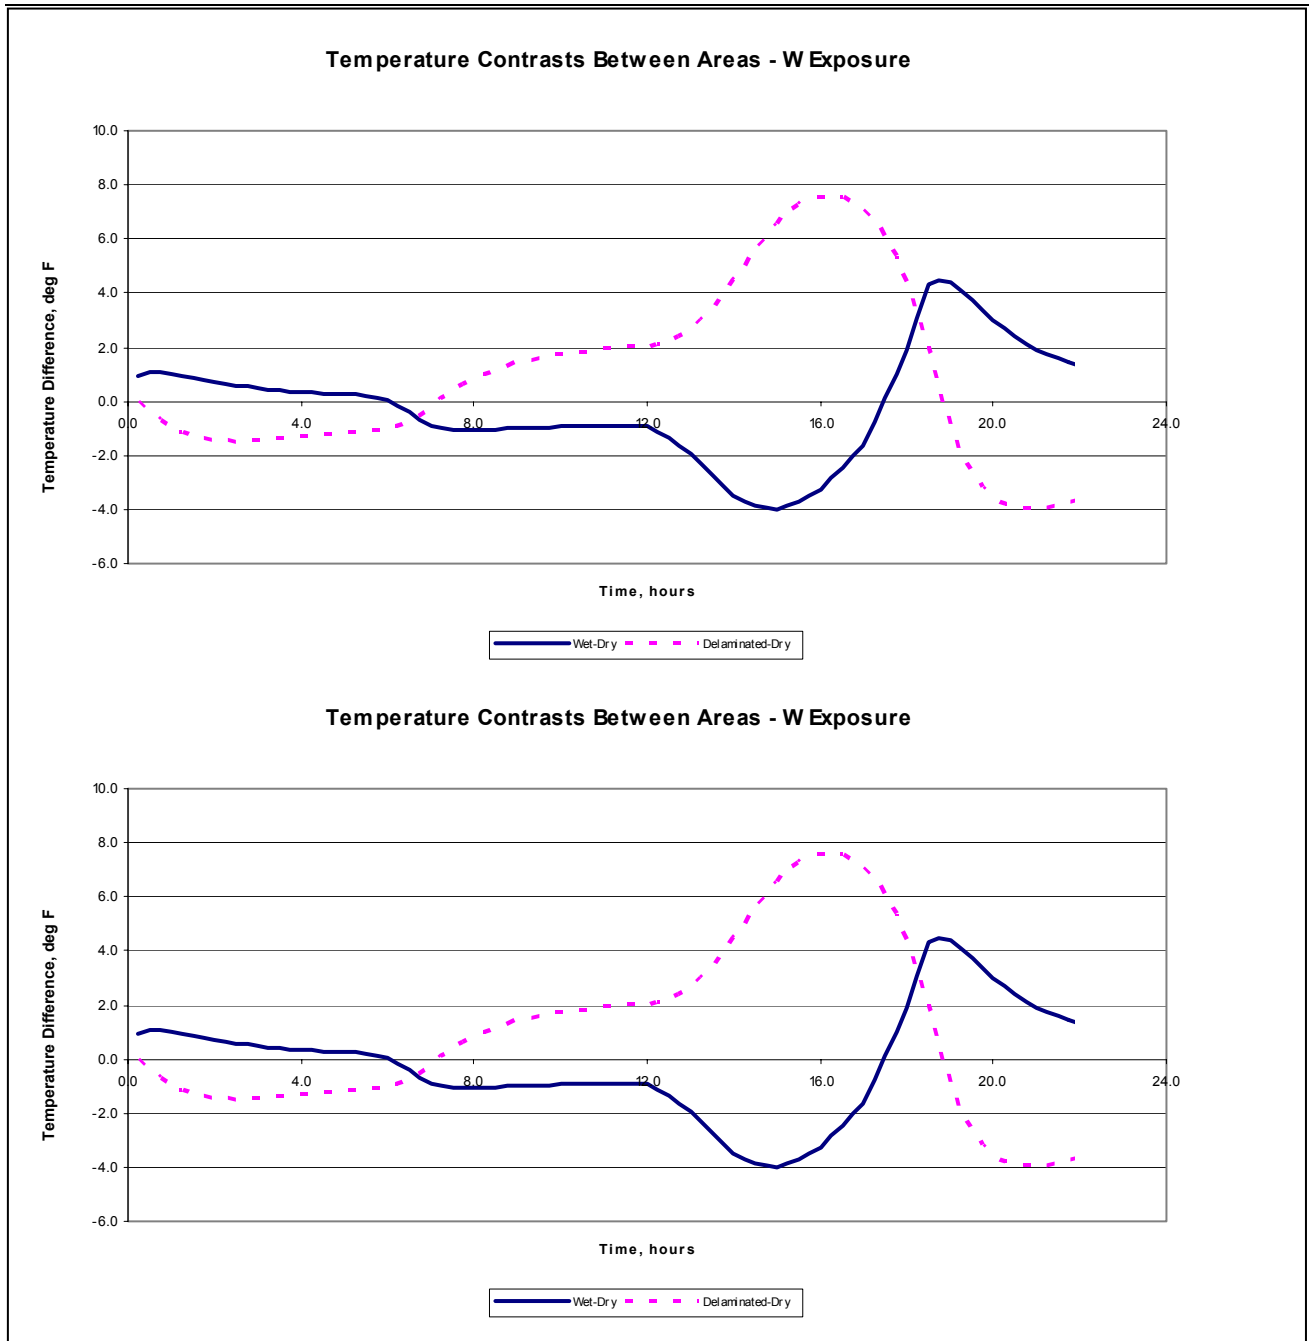
Once the model is developed in the FEA software, it is a comparatively simple and short effort to evaluate the impact of different conditions. For example, the expected temperature history and contrasts for a different orientation of the wall can be evaluated by changing the solar flux BC to match the new orientation and re-running the model. Figures 10 and 11 present the results for a western facing wall. Note how the timing of the

peaks has shifted to later in the day. The maximum values are also slightly higher. This is due to the combined effects of the solar loading and convective heating from the ambient air. The relative behavior of the three types of wall area, dry, wet, and delaminated, remains the same.

Figure 11. Modeled temperature contrast vs. time for wet-to-dry (solid) and delaminated-to-dry (dashed)
