# Thermographic Evaluation of Concrete Masonry Walls: Have They Been Properly Reinforced?

Gregory R. Stockton

Stockton Infrared Thermographic Services, Inc., Randleman, NC

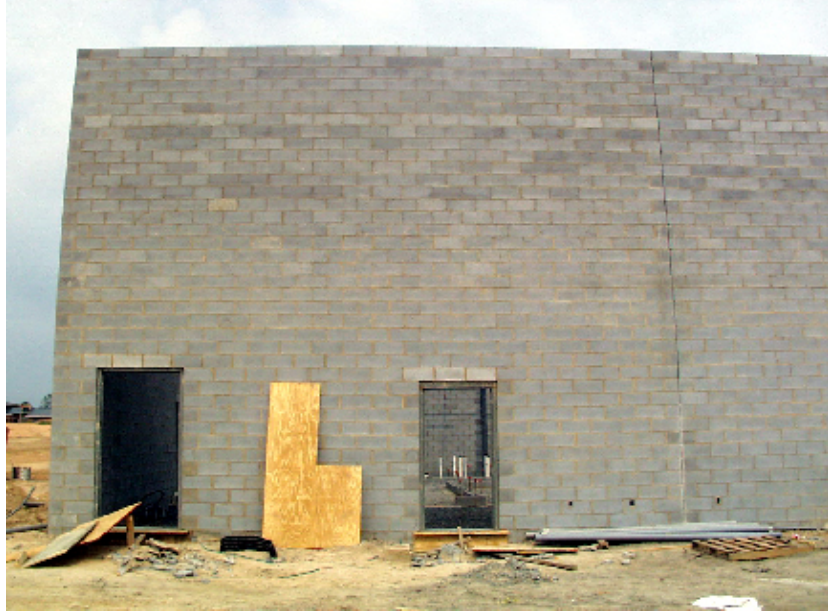
**Figure 1. Typical CMU wall section.**

So until the occupants are miserable, damage is occurring or the operation is affected, and as long as energy prices remain relatively low, heat loss is not perceived to be a problem by building owners. That is why performing heat loss surveys for a living does make the basis of a very good infrared business. Below, I will deal with the structural inspection of the walls of one type of building: CMU or concrete masonry unit. Fig. 1 is a photograph illustrating typical CMU construction.

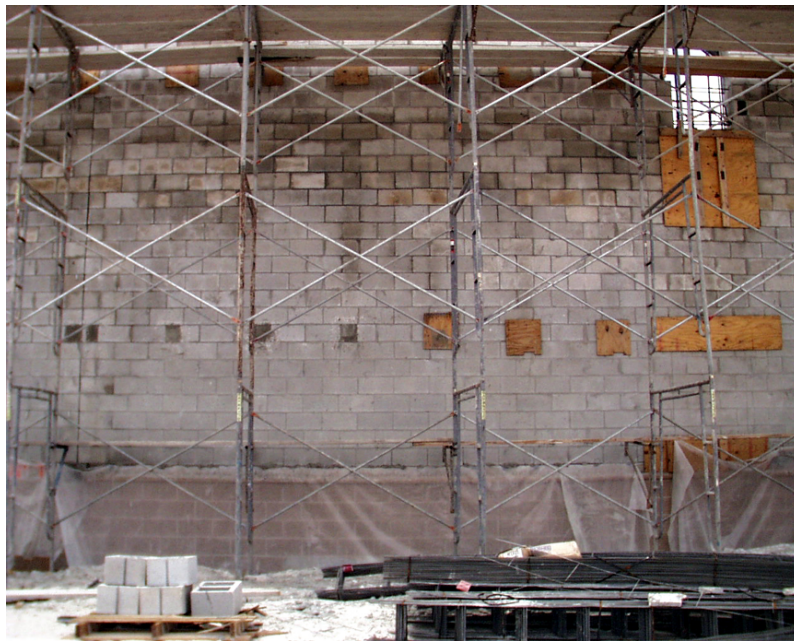
**Figure 3) CMU wall section with inspection ports.**

We find many problems with the construction of CMU walls, but judge these defects are almost never caused by fraud. Instead, poor supervision on the job is the cause for the poor quality. Some buildings are effectively grouted, but it takes extreme and costly measures. For years, the only way that a building owner had of looking into a masonry wall was to drill (or hammer) a hole in it. This testing method does not work, because only a small sample is tested. X-ray testing is *so* slow and expensive, that it is usually cheaper to knock the wall down and start over if its structural integrity is called into question. If the owner really wants to make sure that the grouting and rebar are in the wall, the most popular means is to require the installation of inspections ports or holes, cut in the block faces. These are installed at every lift height and at all grouted vertical pilaster locations as shown in Fig. 3. This is a very costly, time-consuming and sloppy method. That is why infrared is so valuable. It is fast, inexpensive and accurate.
